# National Transportation Safety Board Aviation Accident Factual Report

<b>Location:</b>	Soldotna, Alaska	<b>Accident Number:</b>	ANC20LA074
<b>Date &amp; Time:</b>	July 31, 2020, 08:27 Local	<b>Registration:</b>	N4982U (A1); N2587M (A2)
<b>Aircraft:</b>	De Havilland DHC-2 (A1); Piper PA 12 (A2)	<b>Aircraft Damage:</b>	Substantial (A1); Substantial (A2)
<b>Defining Event:</b>	Midair collision	<b>Injuries:</b>	6 Fatal (A1); 1 Fatal (A2)
<b>Flight Conducted Under:</b>	Part 135: Air taxi & commuter - Non-scheduled (A1); Part 91: General aviation - Personal (A2)

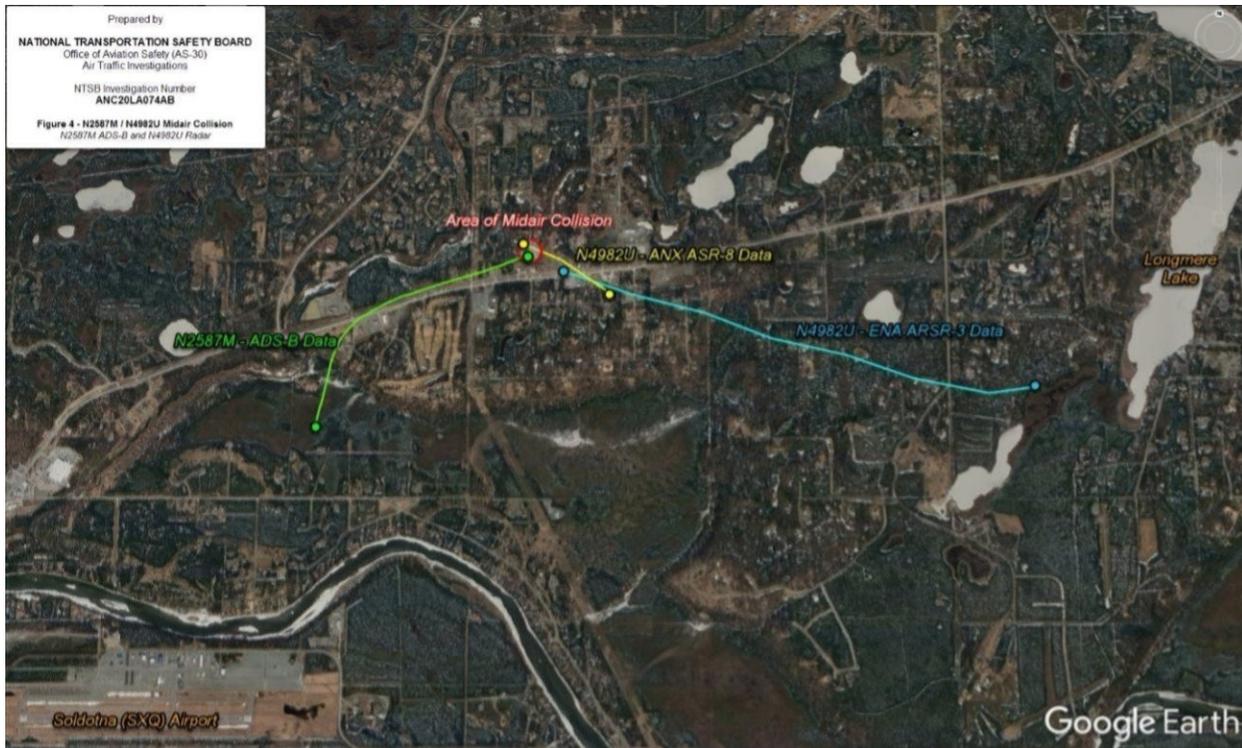
Flight track data revealed that the DHC-2 was traveling northwest about 78 knots (kts) groundspeed and gradually climbing through about 1,175 ft mean sea level (msl) when it crossed the Sterling Highway. The PA-12 was traveling northeast about 1,175 ft msl and about 71 kts north of, and parallel to, the Sterling Highway. The airplanes collided about 2.5 miles northeast of the Soldotna airport at an altitude of about 1,175 ft msl. See figure 1 for the airplanes' flight tracks.

Figure 1 - Flight track. ADS-B data (N2587M) and ENA/ANX radar data (4982U).

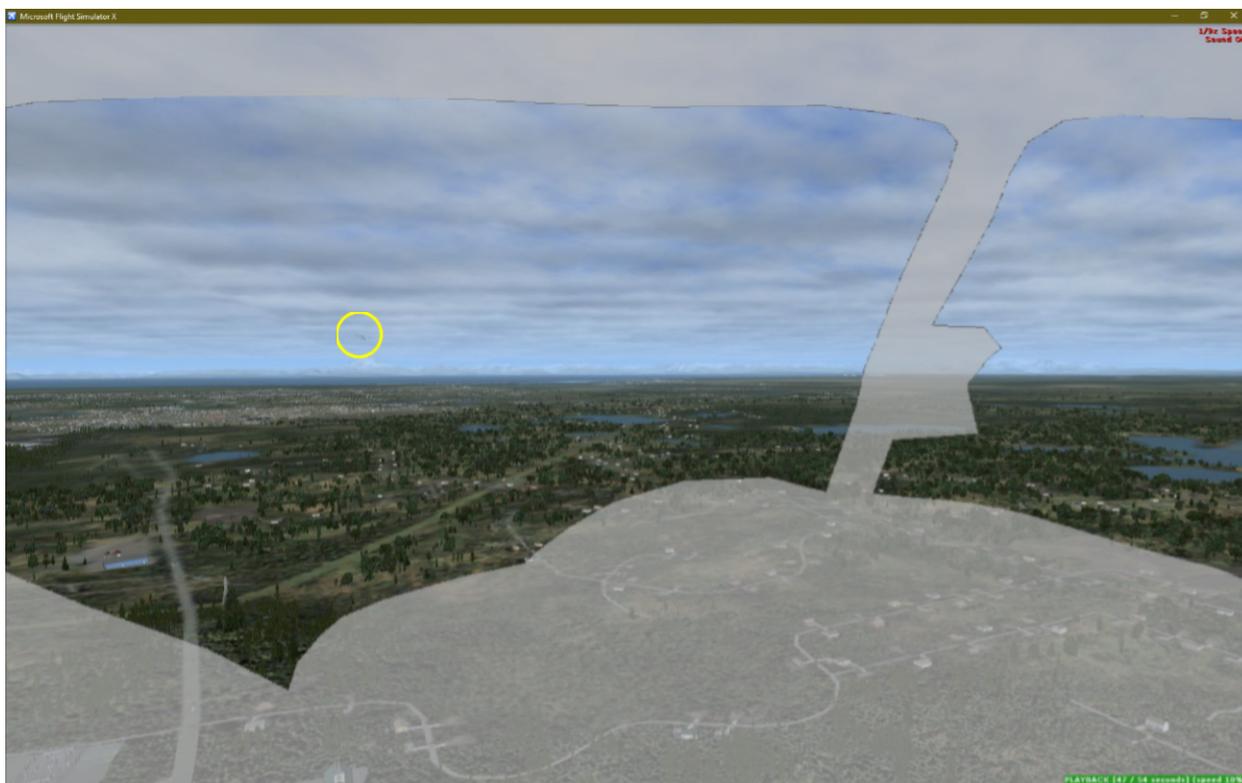
The cockpit visibility study revealed that for the 53-second period before the collision, the Piper would have been unobscured and visible from the DHC-2 pilot through the DHC-2 left windshield.

Figure 2 - Recreation of the view from the DHC-2 cockpit at 0826:27 (5.3 seconds before the collision). The location of the PA-12 is indicated by the yellow circle.

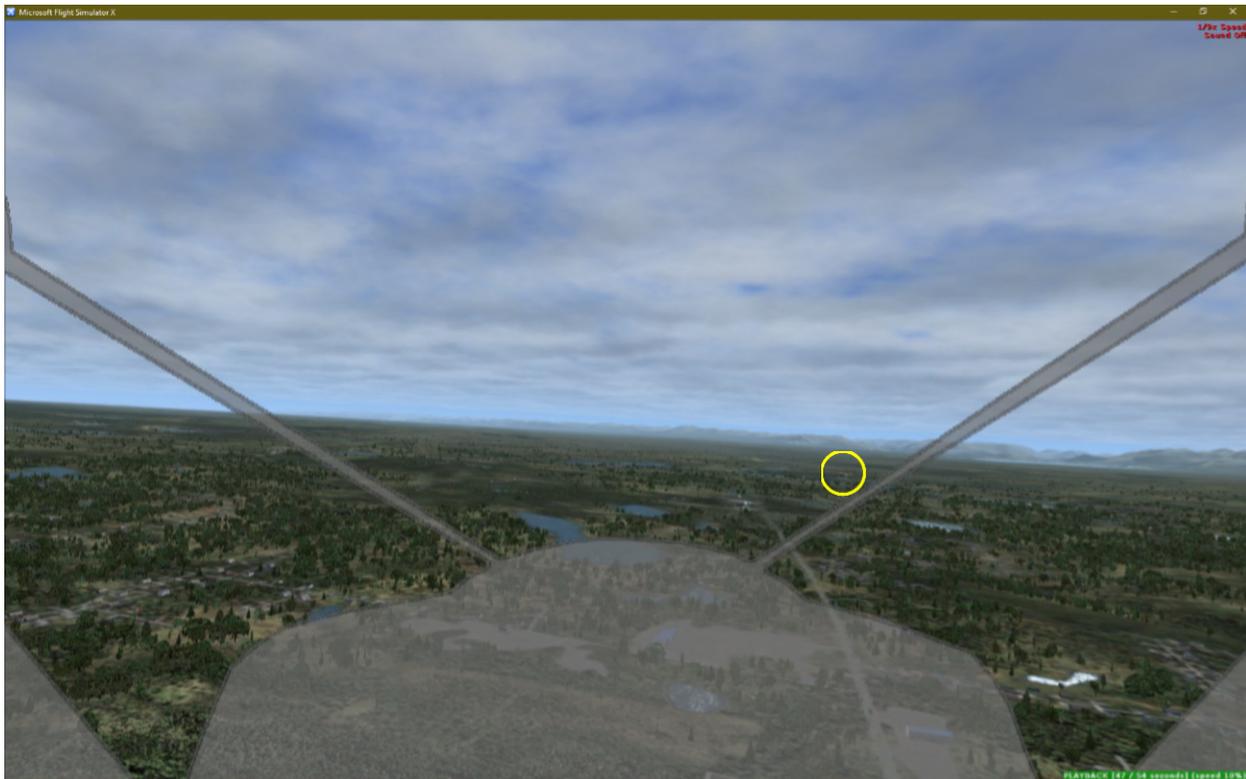
Regarding whether the PA-12 pilot could have seen the DHC-2, between 0825:39 to just before 0825:51 (12 seconds) the DHC-2 would have been unobscured and visible through the PA-12

right window. The DHC-2 would have then been obscured behind the PA-12 right wing root until about 0825:58. The DHC-2 would then have appeared on the right edge of, or been obscured by, a structural support tube inside the cockpit from about 0825:58 to about 0826:04 (6 seconds). From 08:26:04 to the collision at 08:26:32.3 (28.3 seconds), the DHC-2 would have been unobscured and visible in the PA-12 windshield, just to the left of the support tube.

Figure 3 - Recreation of the view from the Piper cockpit at 0826:27 (5.3 seconds before the collision). The location of the DHC-2 is indicated by the yellow circle.
